INVESTIGATION NO. 2811
THE ATCHISON, TOPEKA & SANTA FE RAILWAY COMPANY
REPORT IN RE ACCIDENT
NEAR MAINE, ARIZ., ON
JULY 3, 1944

Railroad: Atchison, Topeka & Santa Fe
Date: July 3, 1944
Location: Maine, Ariz.
Kind of accident: Derailment
Train involved: Passenger
Train number: 19
Engine number: 3774
Consist: 14 cars
Estimated speed: In excess of 70 m. p. n.
Operation: Automatic block-signal system
Track: Double; 4°45' curve; 1.1333 percent descending grade westward
Weather: Clear
Time: About 11:33 p. m.
Casualties: 4 killed; 126 injured
Cause: Excessive speed on curve, as a result of failure of the railroad to provide adequate safeguards to prevent excessive speed on curves

Inv-2811
 Atchison, Topeka & Santa Fe Railway
 Maine, Ariz.
 July 3, 1944

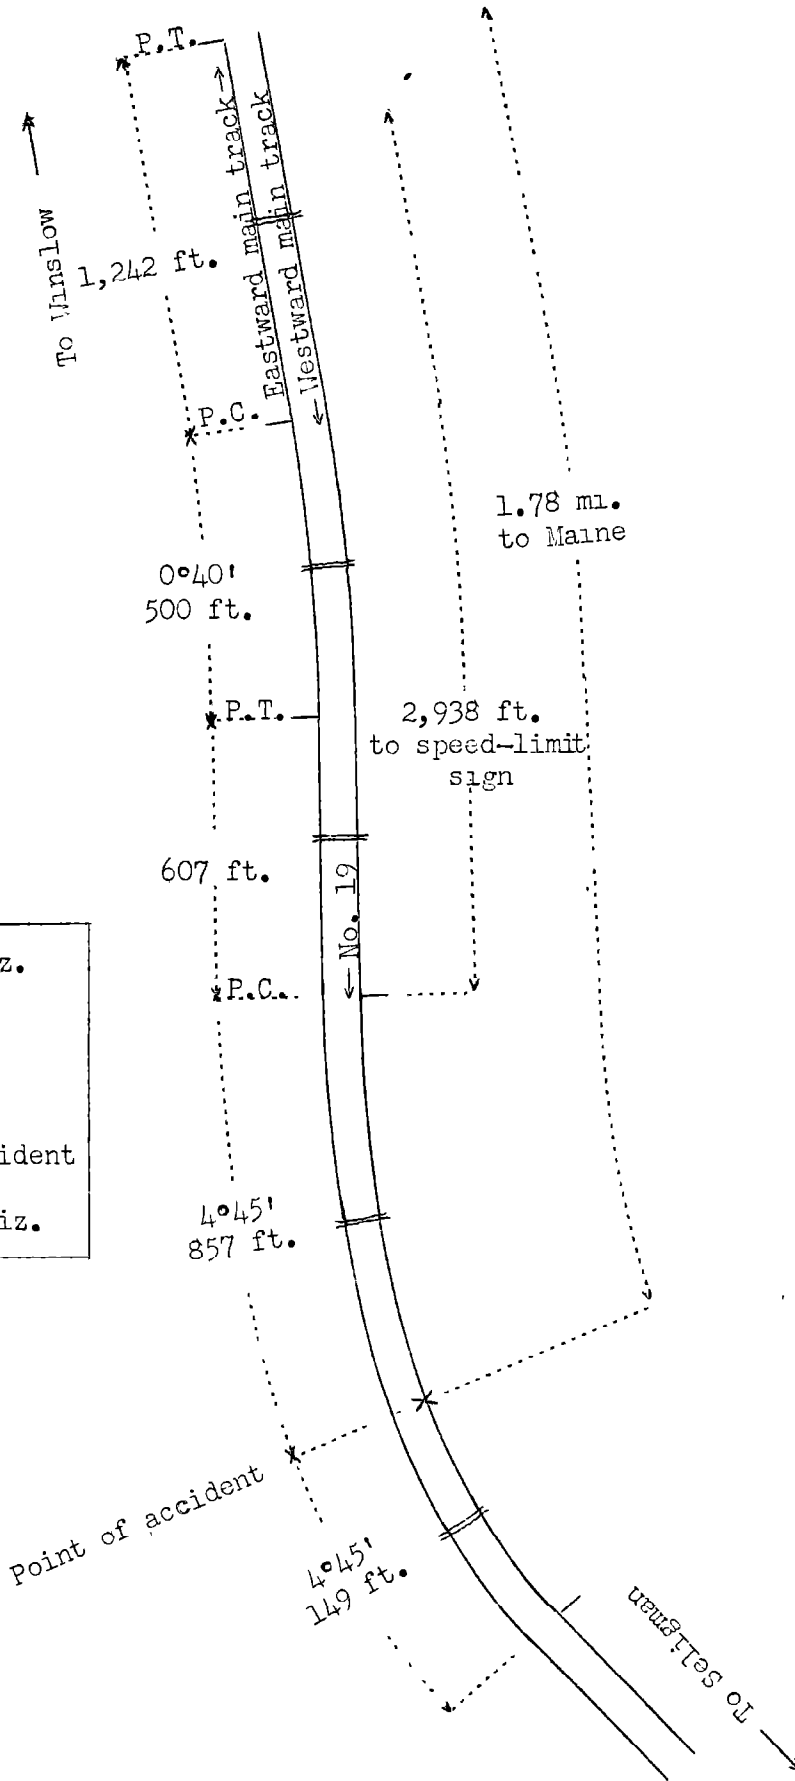
| ○ | Winslow, Ariz. | 70.60 mi. |
| ○ | Bellefont | 6.00 mi. |
| ○ | Maine | 1.78 mi. |
| X | Point of accident | 64.32 mi. |
| ○ | Seligman, Ariz. | |
